Monmouthshire & Brecon Canal, South Wales (Gilwern and Govilon)

Rapid reinstatement of concrete lining to a canal

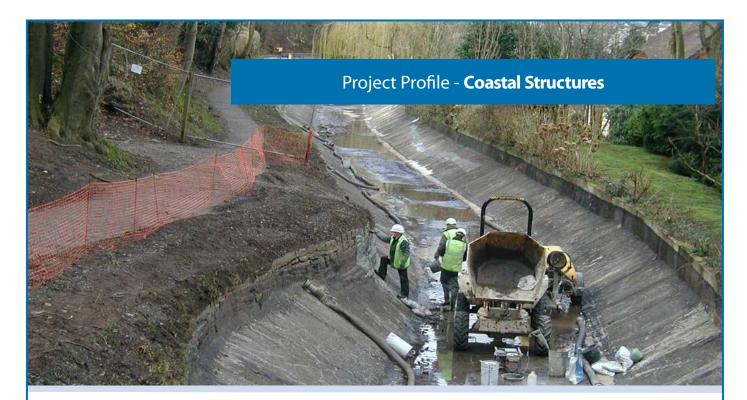
Following draining down approximately 2km of the Monmouthshire & Brecon Canal at Gilwern and Govilon, two sections of the concrete lining were found to have moved and cracked.

A large hole was also found in the towpath wall close to Bridge 96.

In order to ensure that the works were completed within a short timescale as the canal could not be taken out of service for long periods, Fastfill was chosen as the repair mortar. This rapid hardening, fibre reinforced, polymer modified repair mortar is based on Portland cement technology which cures to give reliable strength development and long-term durability due to its advanced shrinkage compensated formulation. The damaged areas were cut out, Fastfill, which sets in as little as 10 minutes, was applied and then the canal was re-filled.
