Repair and protection of structures in coastal environments

Reinforced concrete structures in marine and coastal environments are often subjected to premature deterioration and failure as a result of the extreme conditions to which they are exposed. **Chris Lloyd** and **Graham James** of **Flexcrete Technologies** look at repair and corrosion prevention measures.

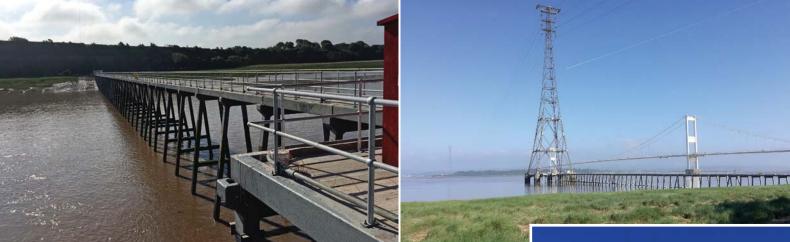
Above and right: The repaired Aust Jetty in the River Severn.

Extensive repairs were required to Aust Jetty, a jetty in the River Severn. Built in the 1960s, the trestle-type reinforced concrete jetty supports and gives service access to a transmission tower downstream of the Severn Bridge at Aust. The tower is one of two that span the Severn Estuary and are taller than a 53-storey block, making them the second highest in the UK. Large-scale concrete repairs were required to the legs of the jetty, plus the main platform. This was a challenging project in a testing environment, as large sections of the plinths are submerged for long periods of time, meaning that only a limited time frame was available to place concrete repair materials and allow them to set. It was also important that once in place, the materials were not adversely affected by immersion. Anti-carbonation protection was required on the top section of the jetty, plus levelling and anti-slip deck protection was needed on the main platform to allow maintenance work to be carried out safely.

Once the defective concrete was cut out of the legs of the jetty by application contractor QST, a cementitious protective coating was applied to the steel reinforcement prior to the application of a waterproof, Class R4 structural repair mortar. Able to be applied up to thicknesses of 80mm in a single application, the mortar exceeds the tensile strength of concrete and its dense matrix offers low permeability to water, even at 10 bar pressure. An anti-carbonation coating was applied to the top section of the jetty and a two-component, epoxy and polymer-modified waterborne cementitious levelling screed was then used to level the jetty platform. Grit was cast into the levelling coating to provide anti-slip protection, so that operatives carrying out maintenance are not at risk of slipping in the hazardous conditions.

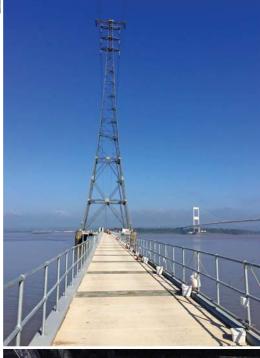
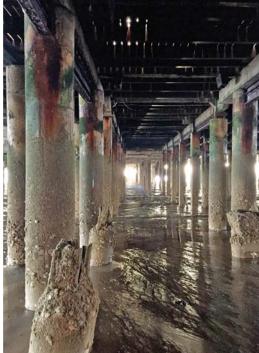
The extent of chloride attack to the reinforced beams and columns at Clacton Pier.

Much of the pier has remained untouched for 90 years or so and as part of a sevenfigure makeover, work is being carried out to modernise and strengthen the landmark's infrastructure. The pier is supported by 2500 reinforced concrete columns and beams, which were showing signs of chloride attack from years of tidal salt-laden seawater. An effective refurbishment solution was required and sustainability was a key issue in making the 146-year-old structure relevant to today's leisure needs.

The refurbishment work is being carried out by Clacton Pier Company's own maintenance team using Flexcrete's waterbased concrete repair materials to meet the sustainability requirements of the project. A specification for the structural renovation work has been devised, which comprises a corrosion-preventative flexible coating for steel reinforcement, followed by a waterproof mortar that can be applied up to 80mm in a single application. The columns and beams are being finished with a fairing coat to reinstate cover and provide a waterproof and anti-carbonation finish. The final protection overall is with a cementitious coating, which provides structural waterproofing and importantly protection from future chloride ingress. With some 2500 columns to be refurbished, this is a long-term project that is likely to extend over several years to come.

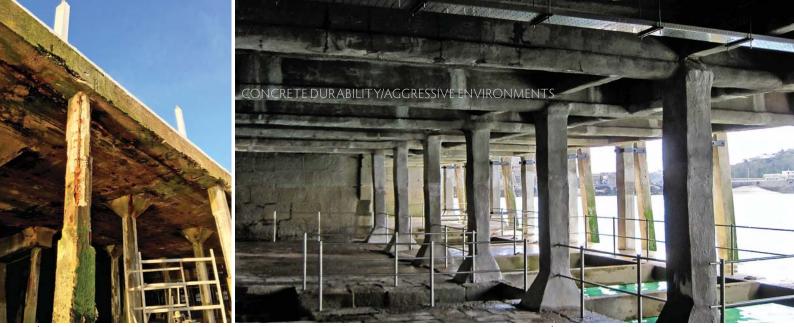
Cementitious coating has been applied at St Peter Port Docks.

Part of the works involved chloride protection of concrete-encased steel columns located in a 10m tidal zone. The columns were initially protected with a 75mm-thick concrete overlay but the client wanted to increase the protection and durability. A cementitious coating was chosen to provide waterproofing and effective protection against chloride attack. Rapid application of the coating was vital for this project due to the location of the columns in the tidal zone. The coating, which is independently proven to provide at least 29 years' protection against chloride attack, was quickly applied by contractor Concrete Repairs Limited using spray techniques at a thickness of 2mm, rapidly stabilising to resist wash out on early immersion to produce a durable and hardwearing protective coating. The cementitious coating has helped ensure that the structure will achieve a design life of at least 25 years.
