# Chemical Attack and Cementitious Coatings for Concrete Repair and Protection

Graham James OBE and Chris Lloyd, AkzoNobel

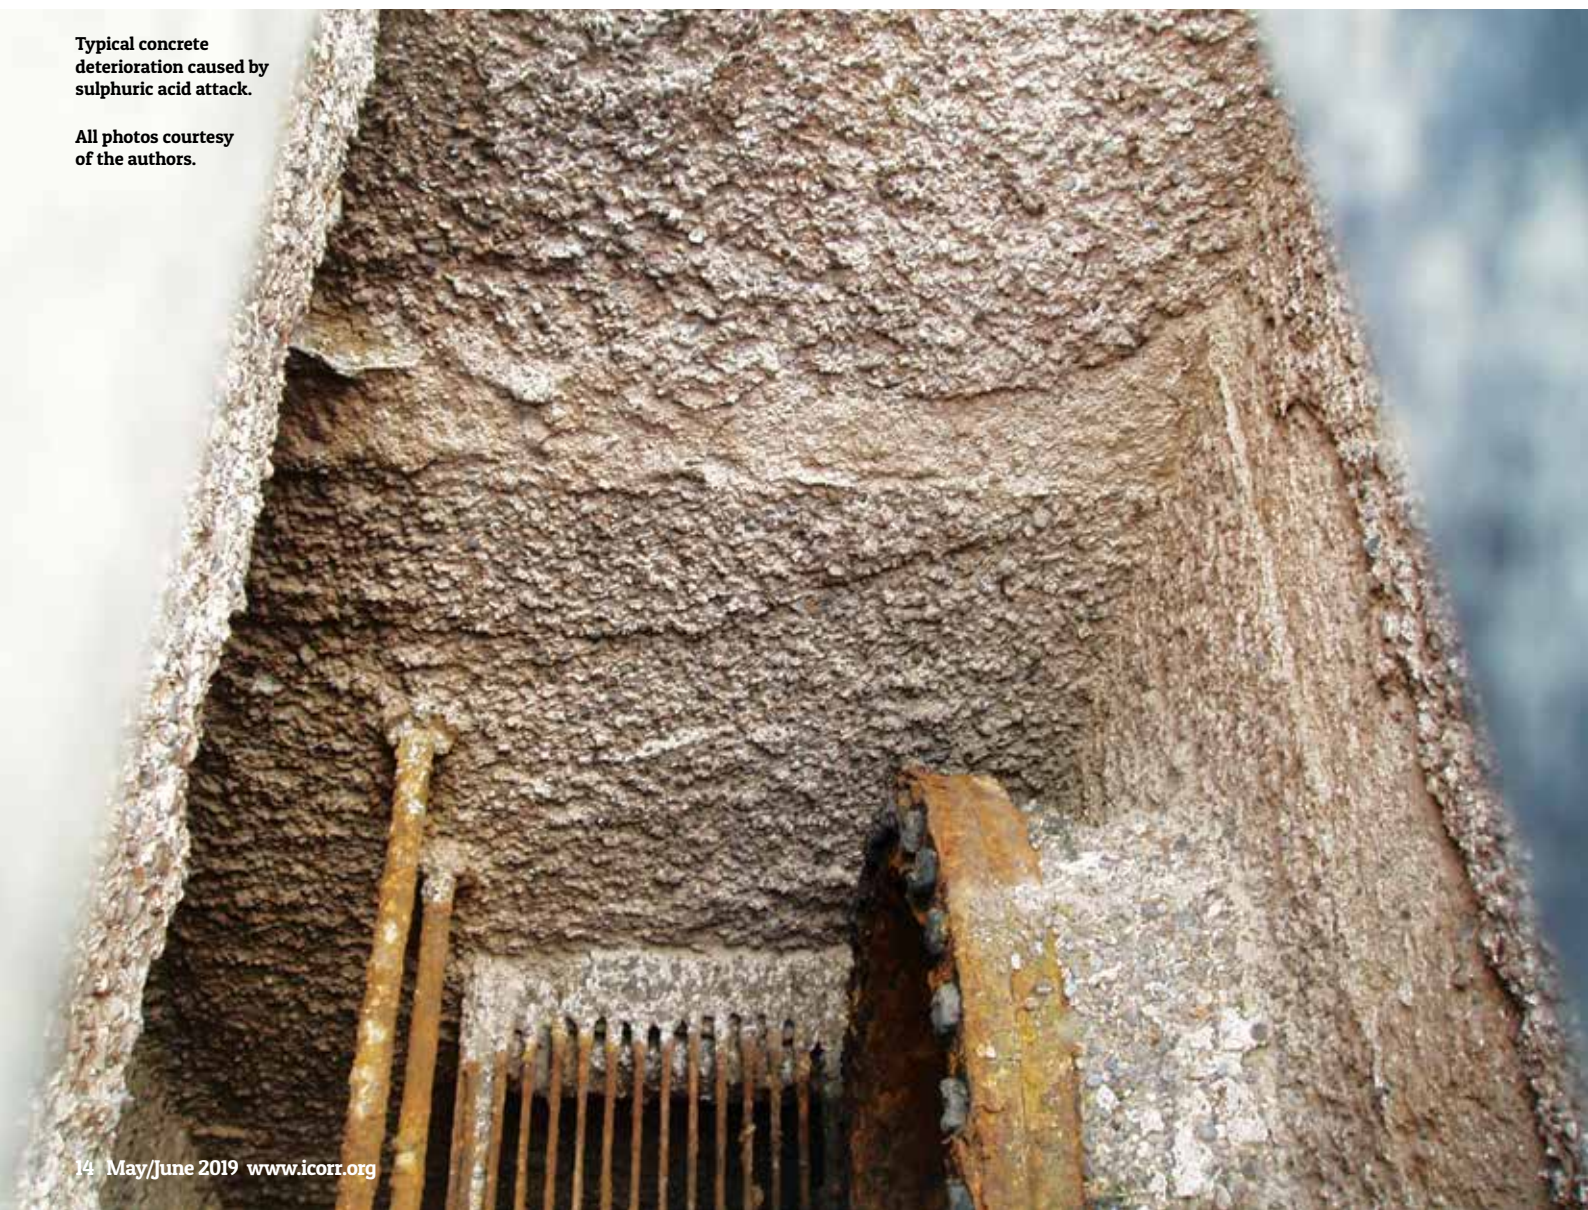
Typical concrete deterioration caused by sulphuric acid attack.

In terms of reinforced concrete in waste water facilities, the most widely feared mechanism for the erosion of concrete in sewerage systems is bacterial in origin. Normal domestic sewage is slightly alkaline and does not contain sulphates in sufficient concentrations to attack concrete directly. The damage which occurs is due to sulphuric acid produced by certain bacteria as a result of changes occurring in the sewage.

Contrary to popular belief, the gas itself does not directly attack concrete, but it will readily dissolve in moisture particularly on the crown or soffit of sewers and on the walls above liquid level, and is then oxidised to sulphuric acid by aerobic organisms of the *Thiobacillus* species. Research conducted in the USA indicated the concentration of sulphuric acid generated within sewerage systems peaks at circa 5%, a level which will readily attack normal concrete. There are various factors which determine the precise concentration but high temperatures are known to greatly encourage bacterial growth.

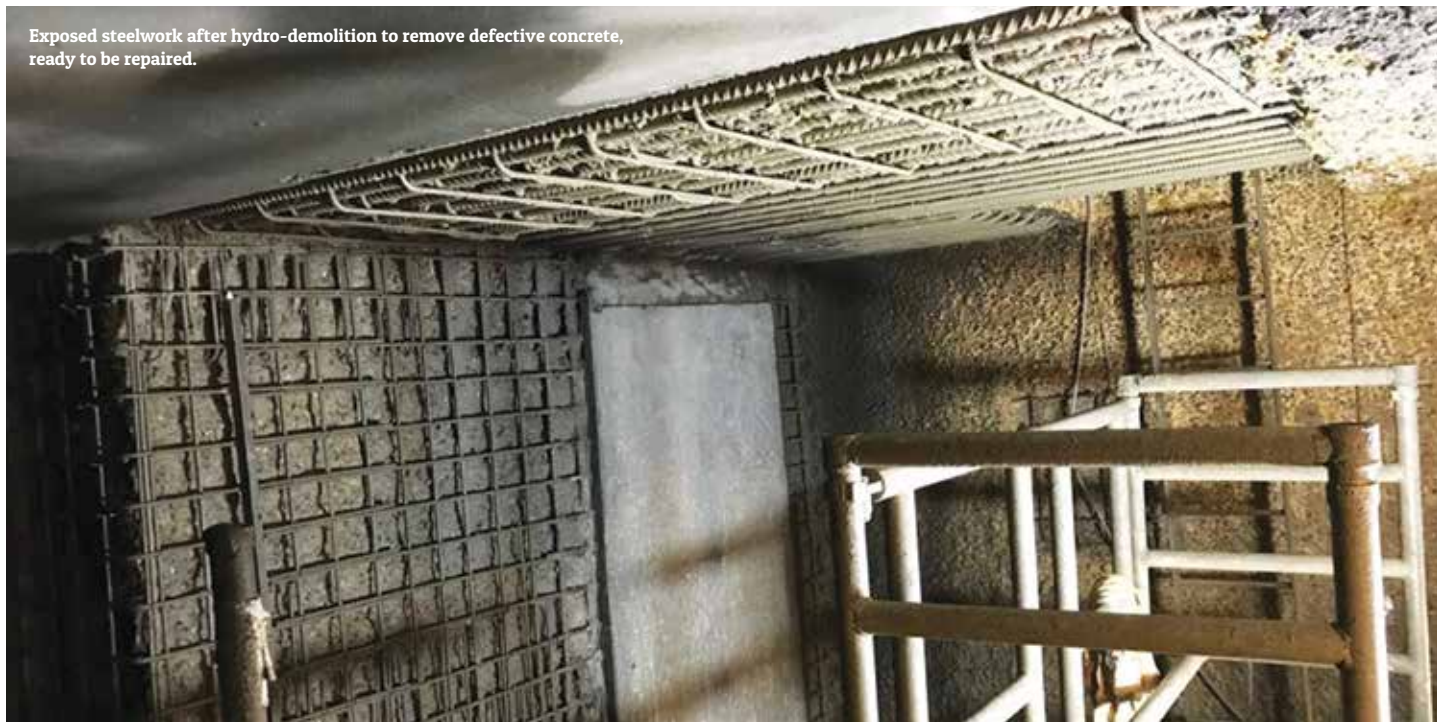
Exposed steelwork after hydro-demolition to remove defective concrete, ready to be repaired.

With regards to repair projects, any defective concrete can be cut out and the steel reinforcement protected with a corrosion preventative coating, prior to the application of concrete repair mortars and protective coatings.

The contractor used hydro demolition to remove damaged concrete, before a dry spray application of the waterproof, class R4 mortar. Following this the cementitious coating was applied at a total dry film thickness of 2mm achieved in 2 coats.
