Protecting bridges against low concrete cover

Bridges are among the most critical structures to protect against low concrete cover to reinforcement. The damaging effects of chlorides from de-icing salts and onerous environments, as well as carbonation attack, can all drastically reduce the design life of structures, leading to expensive maintenance bills and, at worst, force premature demolition. Chris Lloyd of Flexcrete Technologies reports.

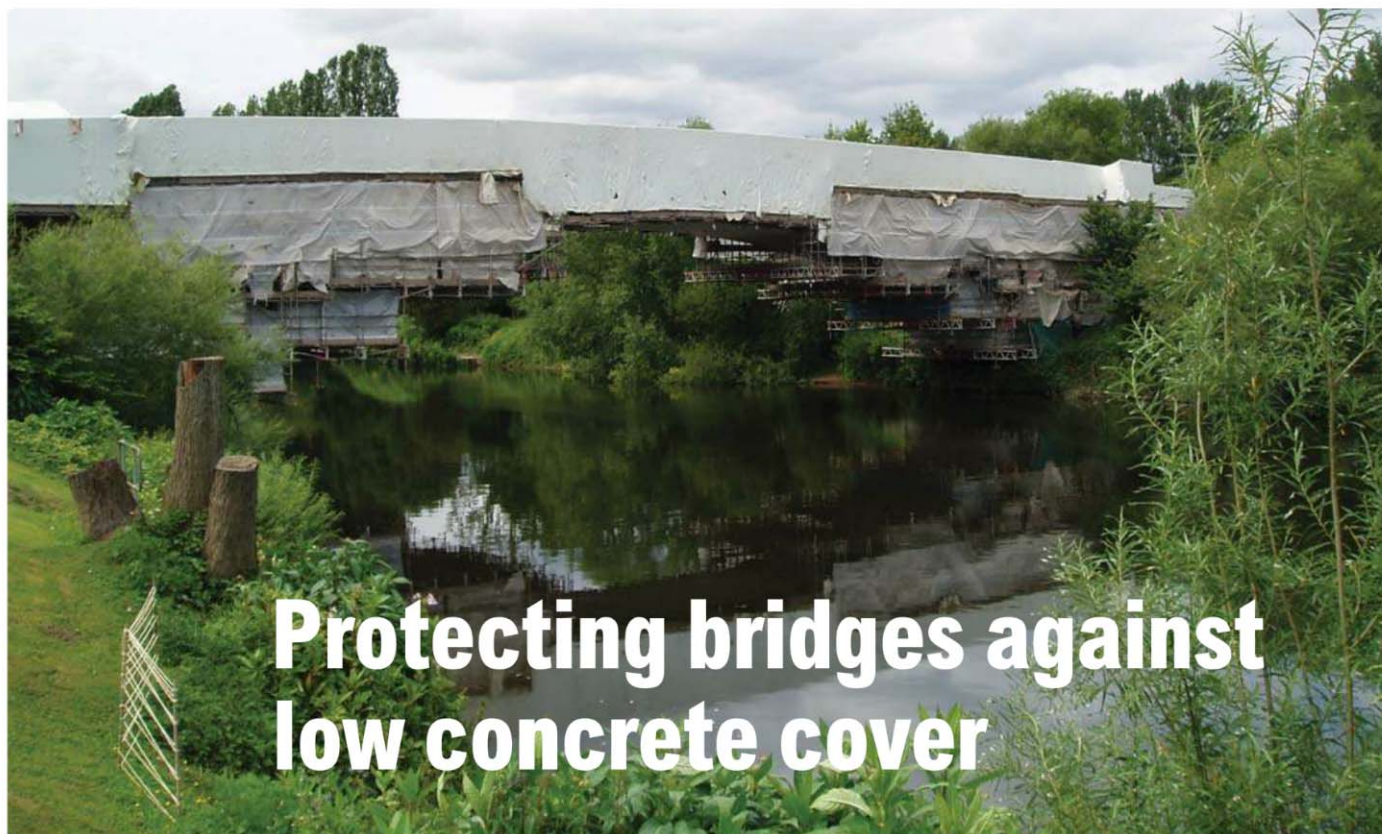
Concrete cover was successfully reinstated on Holt Fleet Bridge in Worcestershire.

The benefits of such technology have been clearly demonstrated on a number of bridges: a 200-year-old, Grade II listed structure in Worcestershire was protected with Cementitious Coating 851 on the underside of

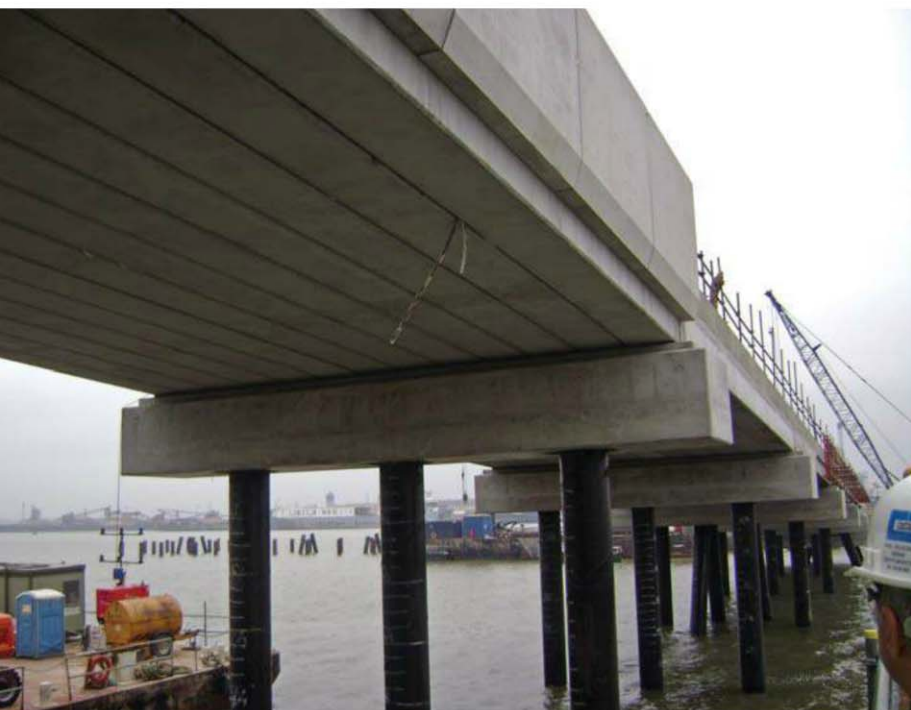
Above: A cementitious coating was used as an innovative engineering solution to reinstate cover on sections of the West Kowloon Expressway in Hong Kong.

On a global basis, 851 has also been used on many structures worldwide, including West Kowloon Expressway – a 4km stretch of highway that carries traffic out to Hong Kong International Airport. The northern section is carried on a viaduct constructed from precast concrete segments; during construction, low cover was detected on a number of segments. Cementitious Coating 851 was approved as an economic and practical solution to enhance effective cover and the contractor blended white and grey shades of 851 to provide a colour-matched solution, which could be used in discreet patches.

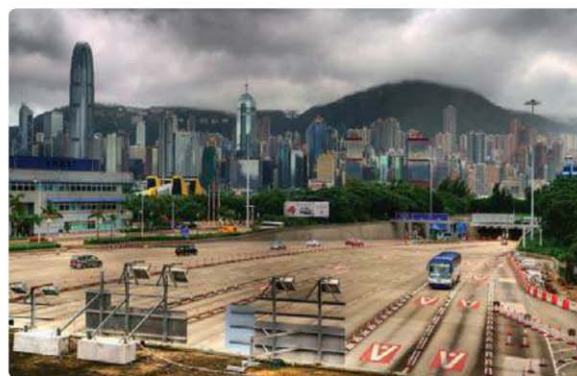
Left: A cementitious coating was also specified to ensure the design life of a new link bridge at Belvedere Riverside Energy from Waste (EFW) facility in south-east London.

Designers have also specified 851 to increase durability on new construction. For example, when a link bridge was constructed at Belvedere Riverside Energy from Waste (EFW) facility in south-east London, the consultants specified 851 to protect the structure from chloride ingress, thereby ensuring the design life of the structure was achieved. Enhancement of 35mm cover to 91 precast beams was required and a 2mm coating of 851 ensured the structure was a barrier to both chloride and water ingress. In order to blend in, the colour of 851 was matched to that of the parent concrete.

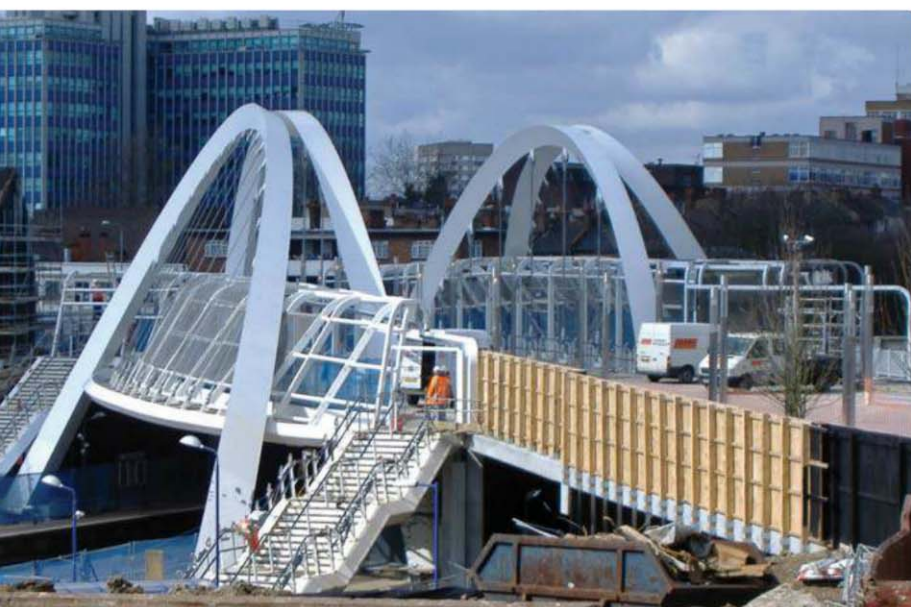
Above: Wembley Stadium railway station footbridge, where cover was reinstated on recently cast abutments.
