State Route 8, Seymour, USA

Providing protection from chloride and water ingress on cracked reinforced concrete bridge columns

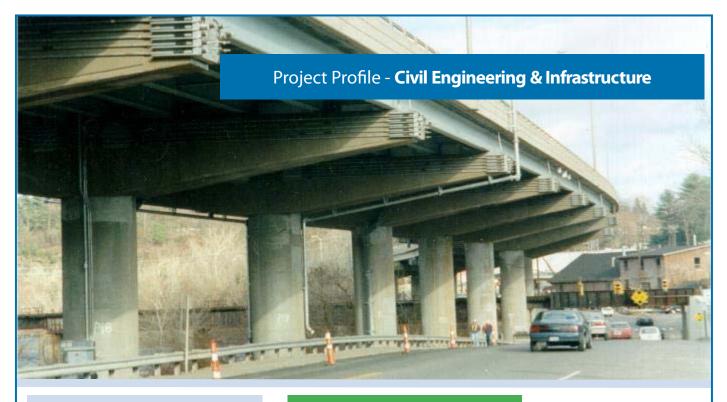
On this section of State Route 8, the supporting columns had previously been repaired with Shotcrete to replace unsound, chloride contaminated concrete.

However, this remedial work was unsuccessful, resulting in crack formation to leave the cathodic protection grid exposed to the elements. These cracks also gave ready access to moisture, carrying further chlorides into the concrete during the winter season. Urgent work was needed to assure that structural integrity could be maintained.

The minimum requirement was a coating membrane that could provide an effective flexible seal which would not become brittle over time. **Cemprotec Elastic** was selected by the Transportation Department as it met the obvious needs in view of its excellent ability to span dynamic cracks in concrete. **Cemprotec Elastic** is also highly waterproof, resistant to a 100 metre head of water. Also, the unique cementitious coating technology is recognised the world over for its outstanding performance in terms of resistance to chloride ion diffusion.
