## Project Profile - Utilities

Ashford Water Treatment Works,  
Somerset

Repair and protection of concrete  
water tanks

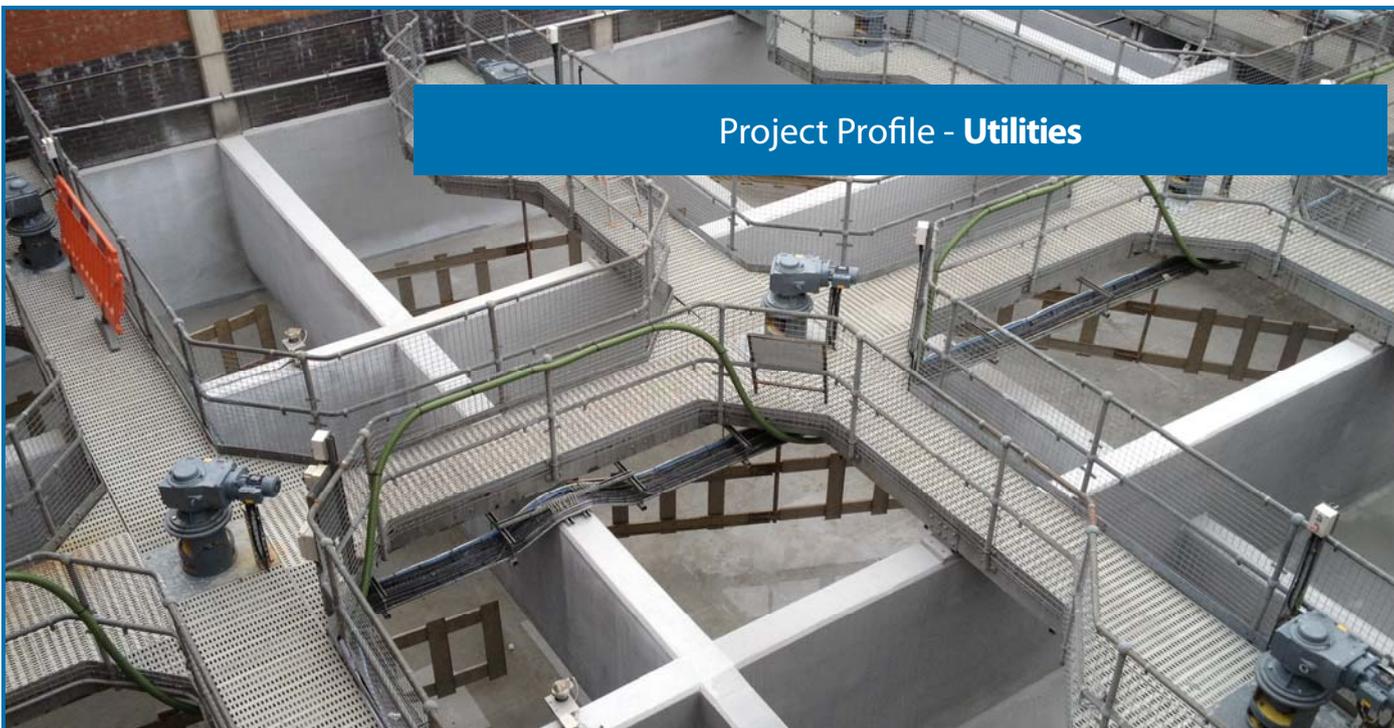
Ashford Water Treatment Works (WTW), near Cannington in Somerset, is one of Wessex Water's showcase facilities and incorporates an education centre on-site for visits from local schoolchildren. The concrete water tanks at Ashford WTW had deteriorated over time due to persistent chemical attack from the treatment process. The reinforced concrete substrate was showing extensive signs of erosion, resulting in 20mm losses of concrete in some areas. A well proven concrete repair and protection solution was sought with a lifespan of at least 20 years.

All areas were first high pressure jet washed to remove the weak concrete before rendering. The whole surface was then overcoated with two 1mm spray applied coats of **Cementitious Coating 851**. A highly advanced, two component, waterborne cementitious modified polymer coating, **851** provides an effective barrier against the effects of acid gases, moisture and chlorides, and also has greatly enhanced chemical resistance.

The application of **Cementitious Coating 851** at Ashford WTW will prevent further chemical attack to the concrete. The slab was also cleaned and primed using **Polymer Admixture 850** to prevent any outgassing before a single 2mm spray coat of **851** was applied. In total, around 24 tonnes of Flexcrete repair materials were provided for this prestigious project.
