Project Profile - Coastal Structures

Malpas Jetty, Truro, Cornwall

Repair and protection of a reinforced concrete jetty in a tidal zone

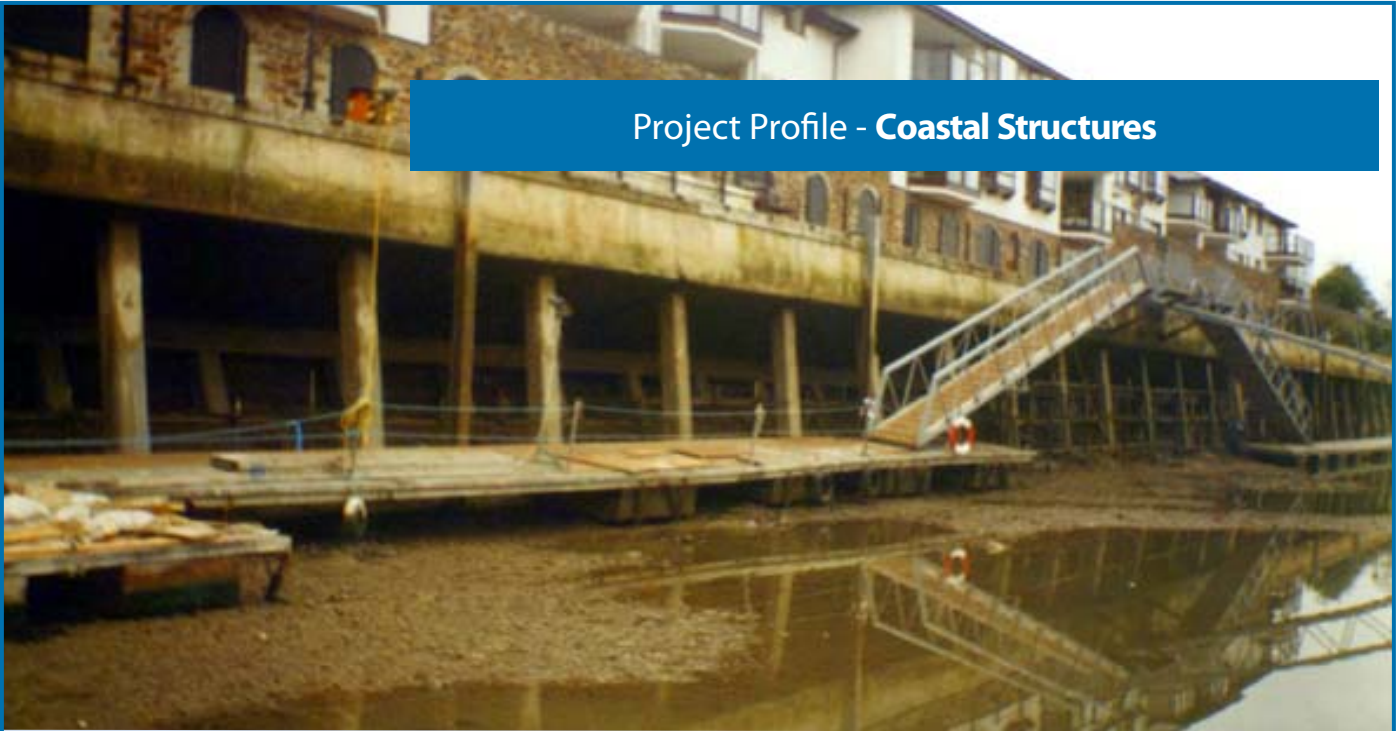
Originally constructed in the 1980's, the privately owned Malpas Jetty had been subject to constant exposure to sea water spray and tidal erosion.

As a consequence, urgent repairs had become necessary to make the structure safe and extend the service life, as large scale failure of the soffits and cross beams had occurred

The scale and complexity of the work dictated the use of a range of Flexcrete products. After a full diagnosis of the faults, all loose and defective concrete was cut out to reveal the steel reinforcement which was grit blasted to Sa 2½ and treated with two coats of **Steel Reinforcement Protector 841**. To reinstate the columns in the tidal zone, **Marine Mortar S** was chosen because of its early resistance to wash out. For other overhead repairs, the contractor used **Monomix**, a medium weight high build mortar for hand applied repairs. On completion of the repairs, all areas were treated with 2mm of **Cementitious Coating 851** to provide long term chloride protection, thus significantly extending the service life.
