Project Profile - Utilities

Swanland Water Tower, East Riding of Yorkshire

Waterproofing of concrete roof and repair to internal soffit beams

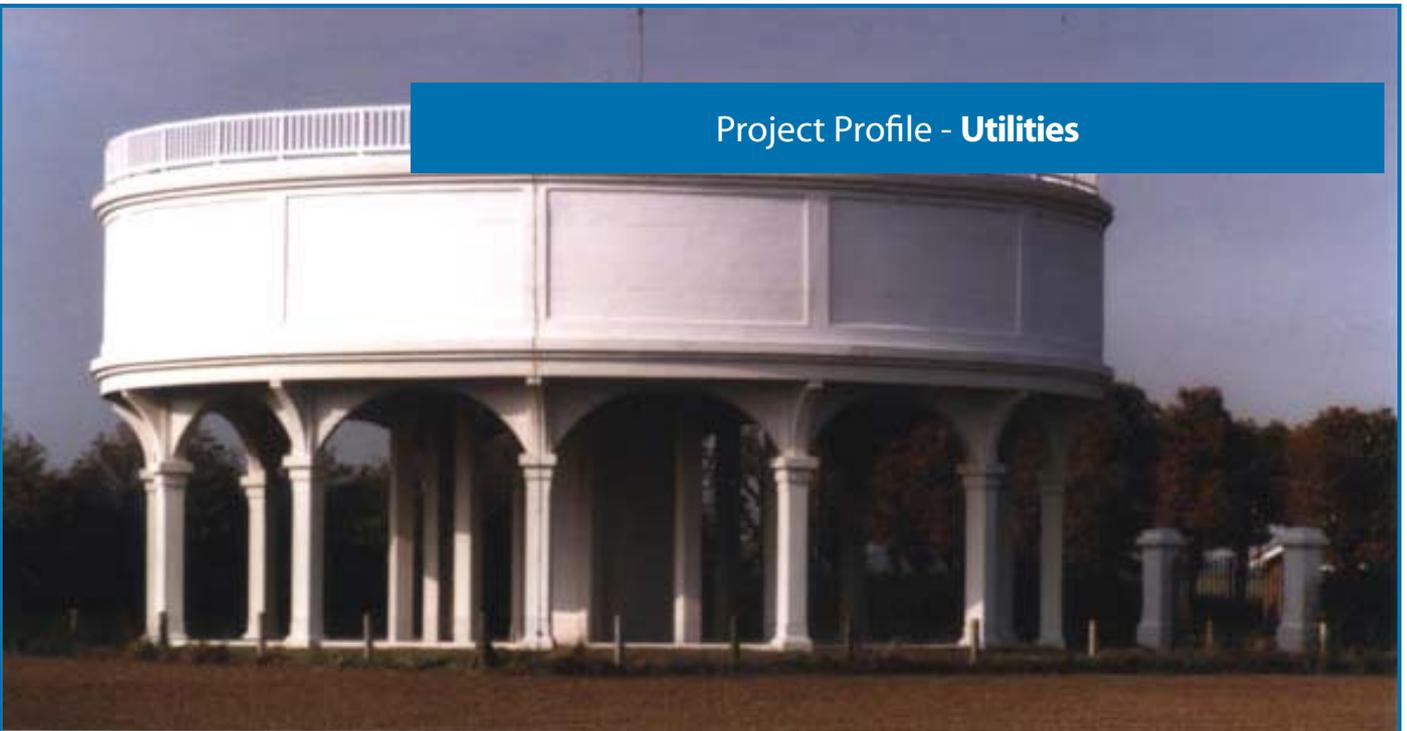
The deterioration in the condition of the Swanland Water Tower required the use of a range of materials to bring the structure up to standard following leakage of rainwater through the roof section causing corrosion.

Given the diverse nature of the damage, it was important to specify a system with compatible components, and the extensive range of cement-based products from Flexcrete was chosen. After cutting back to a sound core, **Steel Reinforcement Protector 841** was applied as a 2mm layer to passivate and provide a defence against further corrosion. The cover was then replaced with **Monomix**, a shrinkage compensated waterproof mortar with rapid curing characteristics. The surrounding surfaces were then brought up to a fair faced finish with **Monolevel 844SP** which is applied either by float or bag-rubbing technique. To complete the waterproofing, a 2mm layer of **Cementitious Coating 851** was applied by spray equipment to form a dense skin equal to casting an extra metre of concrete cover.
