# A repair project with nostalgic memories

*Even the most durable concrete built to the highest standards needs repair and protection to help extend its design life. This is clearly demonstrated by a concrete repair and coating project recently carried out at Teikyo School, an independent boarding school for Japanese students in Wexham, Buckinghamshire. Chris Lloyd of Flexcrete Technologies reports.*

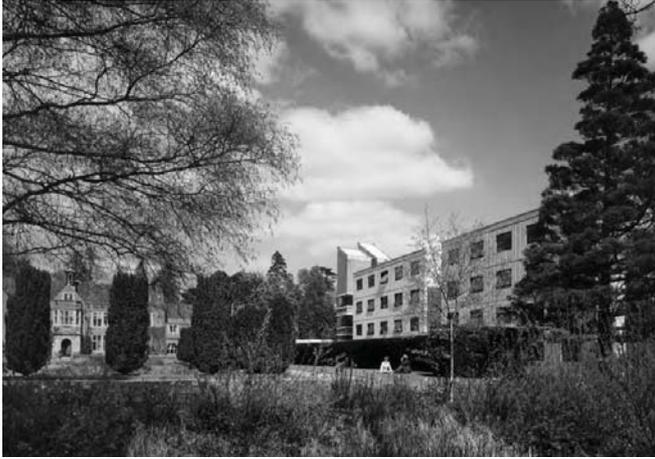
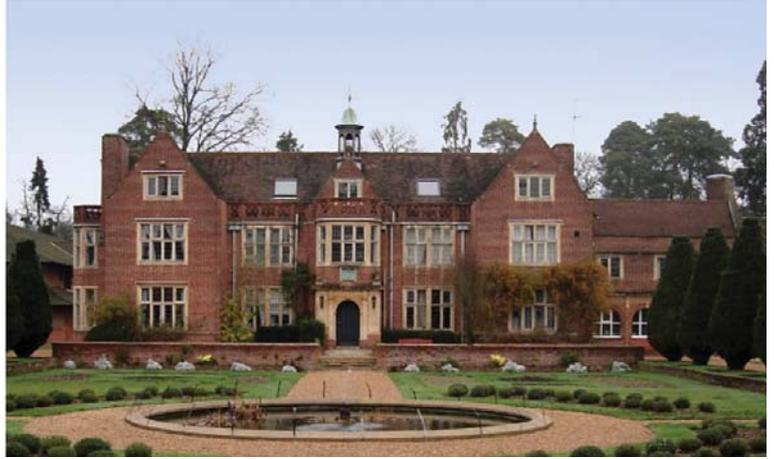
Top of page: The Fulmer Grange Conference and Training Centre; and Teikyo School in Wexham, Buckinghamshire. This Jacobean mansion provides a strong contrast to the accommodation blocks.

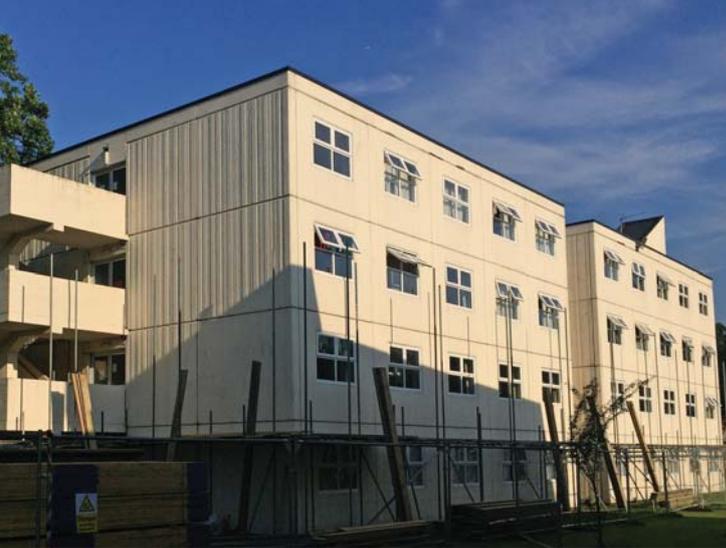
The concrete repair and coating work has transformed the external appearance of the accommodation blocks and will provide Teikyo School with excellent waterproof and anti-carbonation protection for many years before any maintenance is required. This nostalgic project demonstrates that even the most well-designed concrete buildings and infrastructure need some form of repair and protection in order to protect them from the elements and extend their design life. ■

Top left: The accommodation blocks following the coating works.

Following the concrete repairs, a protective, decorative coating was required for application to the complete external façade to enhance the appearance of the two blocks, while providing anti-carbonation protection. Monodex Smooth, an advanced, waterborne, elastomeric coating, was specified. With high diffusion resistance to carbon dioxide, it provides excellent protection from the effects of carbonation, chloride penetration and water ingress, yet allows damp substrates to breathe. It also provides high weatherproof

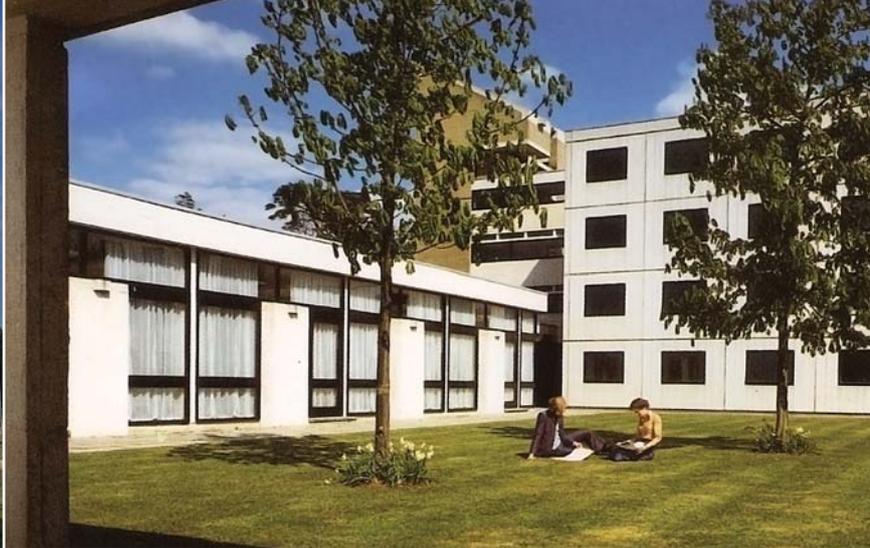
Above: East residential block at the former training centre, with the dining room on the left.

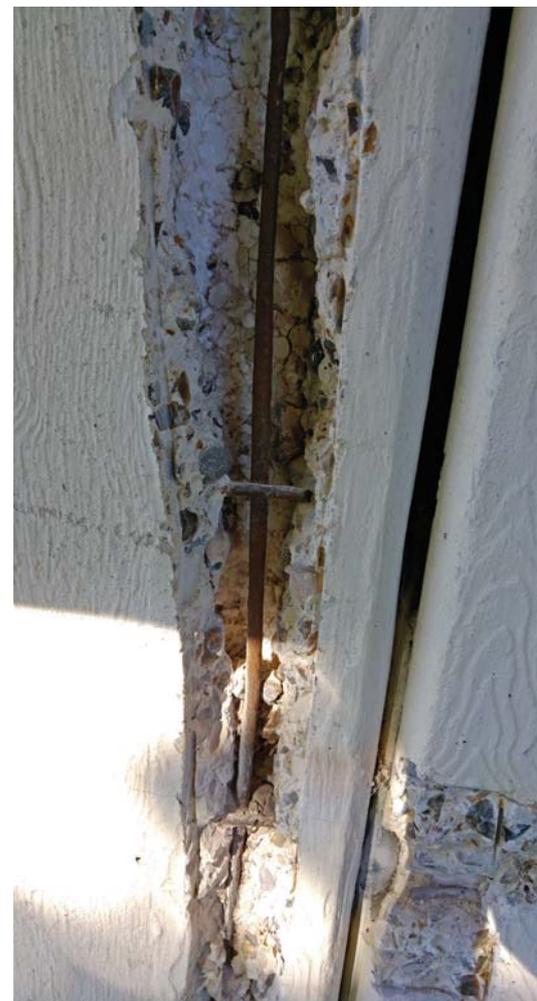
Although the former C&CA Training Centre was built to the highest standards of concrete durability and it was originally perceived that no coating works would be required, significant remedial work was needed in 2015. As a result of spalling on precast panels on the two blocks due to the harmful effects of carbonation over the years, extensive concrete repairs were required, as well as coating of the external walls for decorative and anti-carbonation protection.

The concrete cut back to the steel reinforcement.

As repairs needed to be carried out vertically as well as horizontally, a lightweight repair material was required. Monolite, an ultra-high build, low-density, cementitious mortar, was specified. Able to be applied by trowel up to 100mm in a single application, it is ideal for the cosmetic repair, rendering and profiling of concrete and is suitable for overhead, vertical and horizontal applications. With excellent low sag properties, Monolite is supplied as a single-pack product and only requires the addition of clean water on-site. As it has a water-based formulation, it is safe to use, non-hazardous and virtually odourless. With ultra-low volatile organic compound (VOC) levels, it can be safely applied in sensitive or confined areas, so there was no disruption to Teikyo School students during the refurbishment work.
