Effective refurbishment of reservoir roofs

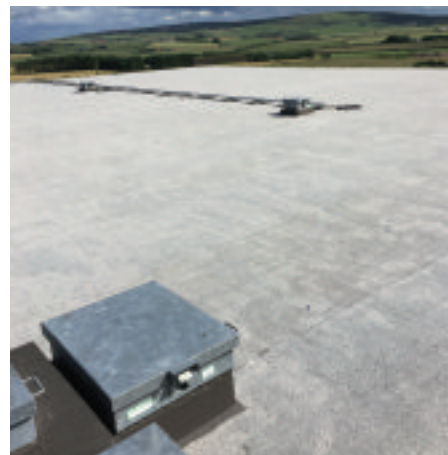
concrete plank construction and considerable movement was expected. As a result, Fraser Bruce Group proposed the reinforcement of the Cemprotect Elastic with Cemprotect Geo80, a thermally bonded non-woven geotextile, to give increased toughness to the coating and enhanced crack bridging properties. Over formed joints, Cemprotect 2000-S, an elastomeric, breathable polyurethane based reinforcing tape, can be used to provide effective waterproofing in these critical areas.
