# Specification of external coatings for social housing refurbishment

When it comes to the refurbishment of social housing, external coatings can play a key role in enhancing the outside appearance of residential properties while extending their design life. Graham James OBE of Flexcrete Technologies Ltd and Matthew Gillborn of the Gunitite Group explain further

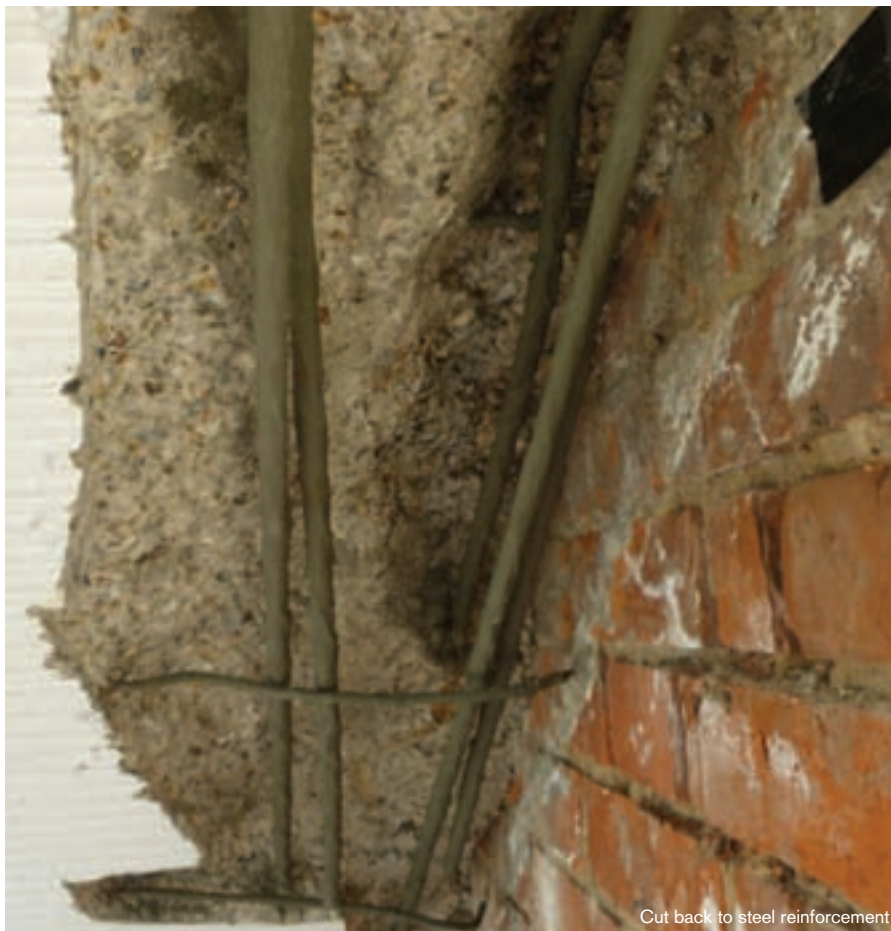
Cut back to steel reinforcement
